MEMOIRS OF THE
ARCHAEOLOGICAL SURVEY OF INDIA
NO. 91

ANGKOR VAT

INDIA'S CONTRIBUTION IN CONSERVATION

1986-1993

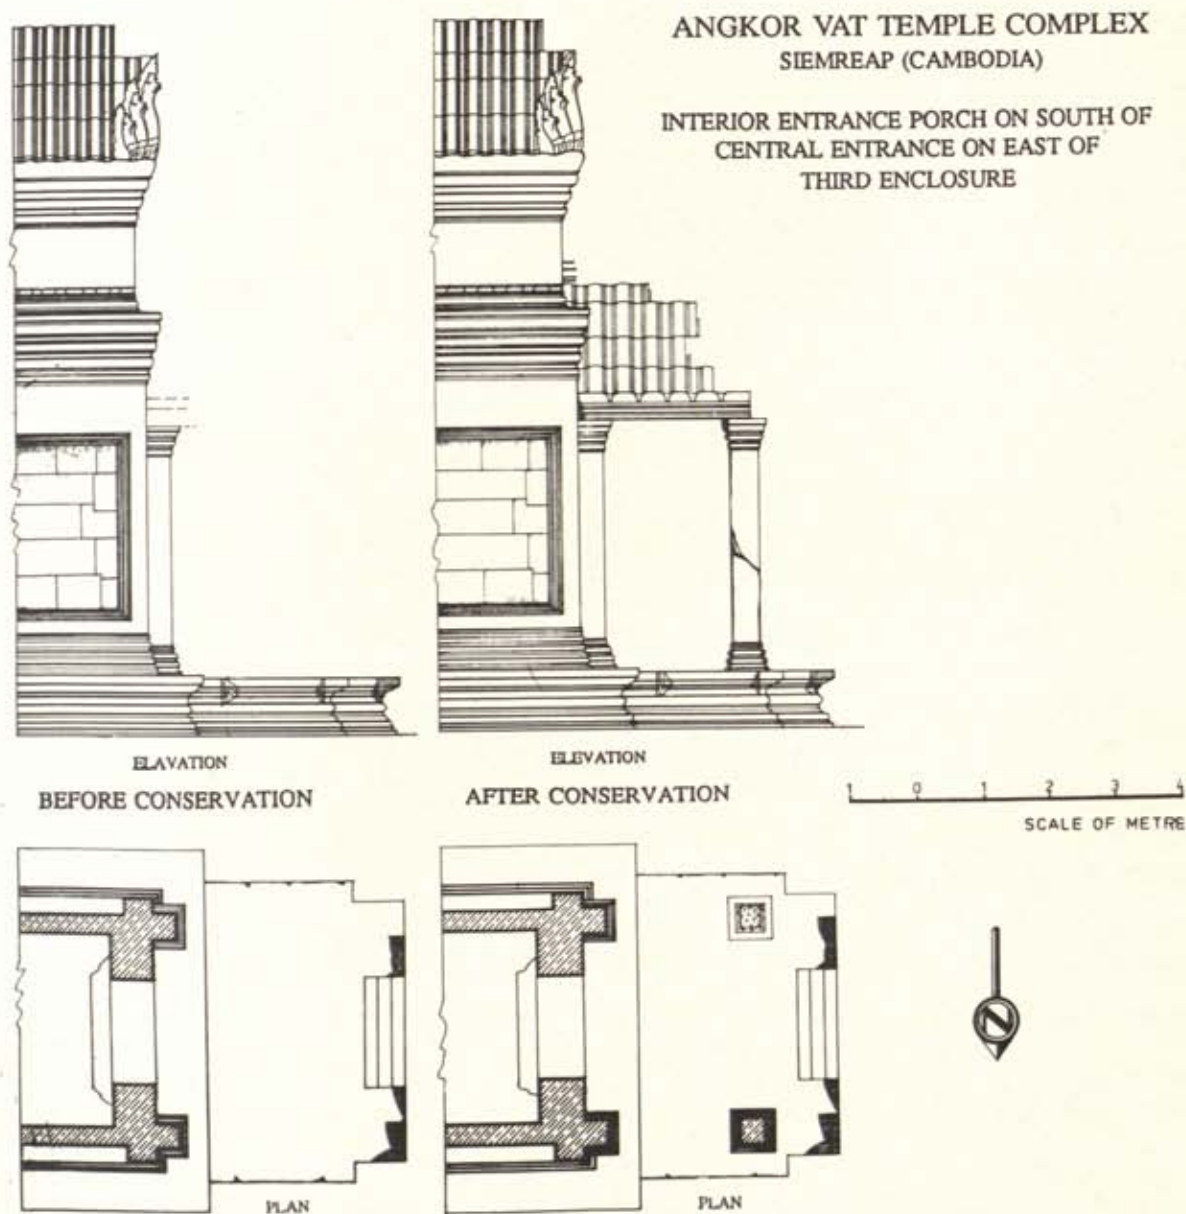
FIG. 7

It may be recalled here that the superstructure of this porch had been dismantled long ago, but one original pillar and an RCC column for the other pillar with two beams over them were standing. Even the original pillar had vertical cracks showing the tendency of flaking. In addition, the architectural members of the plinth and the flooring had been dislodged. Vegetation was growing profusely in the gaps of the masonry. Therefore, the dismantling of even the exant portion was unavoidable.

Before executing further reconstruction of the porch, the damaged pillar was suitably mended and strengthened by providing concealed steel rods and brackets. In the place of missing pillar, an RCC pillar was cast *in situ*. In addition, a beam which had broken into three pieces was mended and strengthened by providing concealed I-section girder. After placing the available two beams over the pillars, the vaulted roof was reconstructed by using fourteen (14) architectural members (refer pls. XXVIII-XXX). It may be remembered that many of the members including front beam and *torana* were missing even before it was dismantled (fig. 7). The structure was watertightened by grouting and pointing.

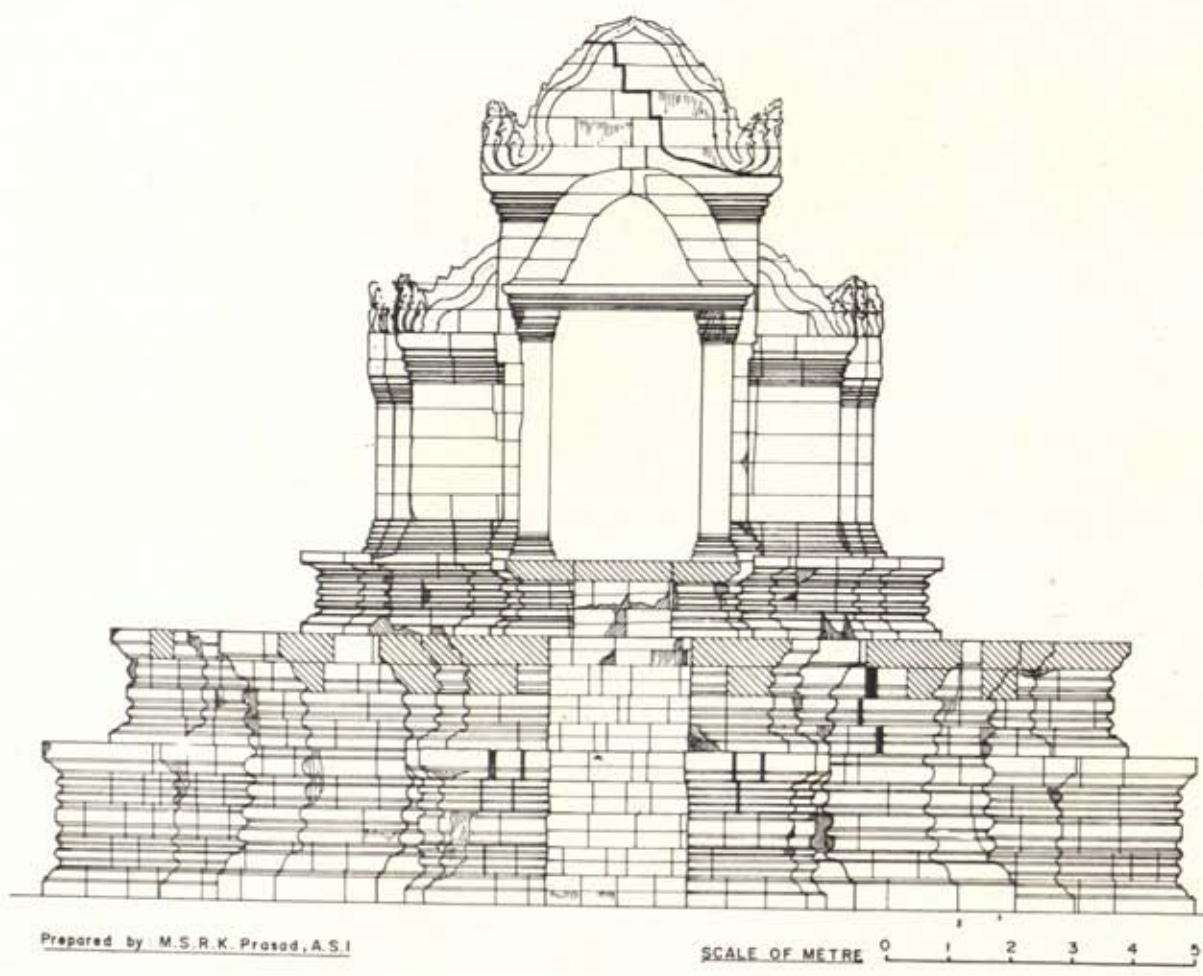
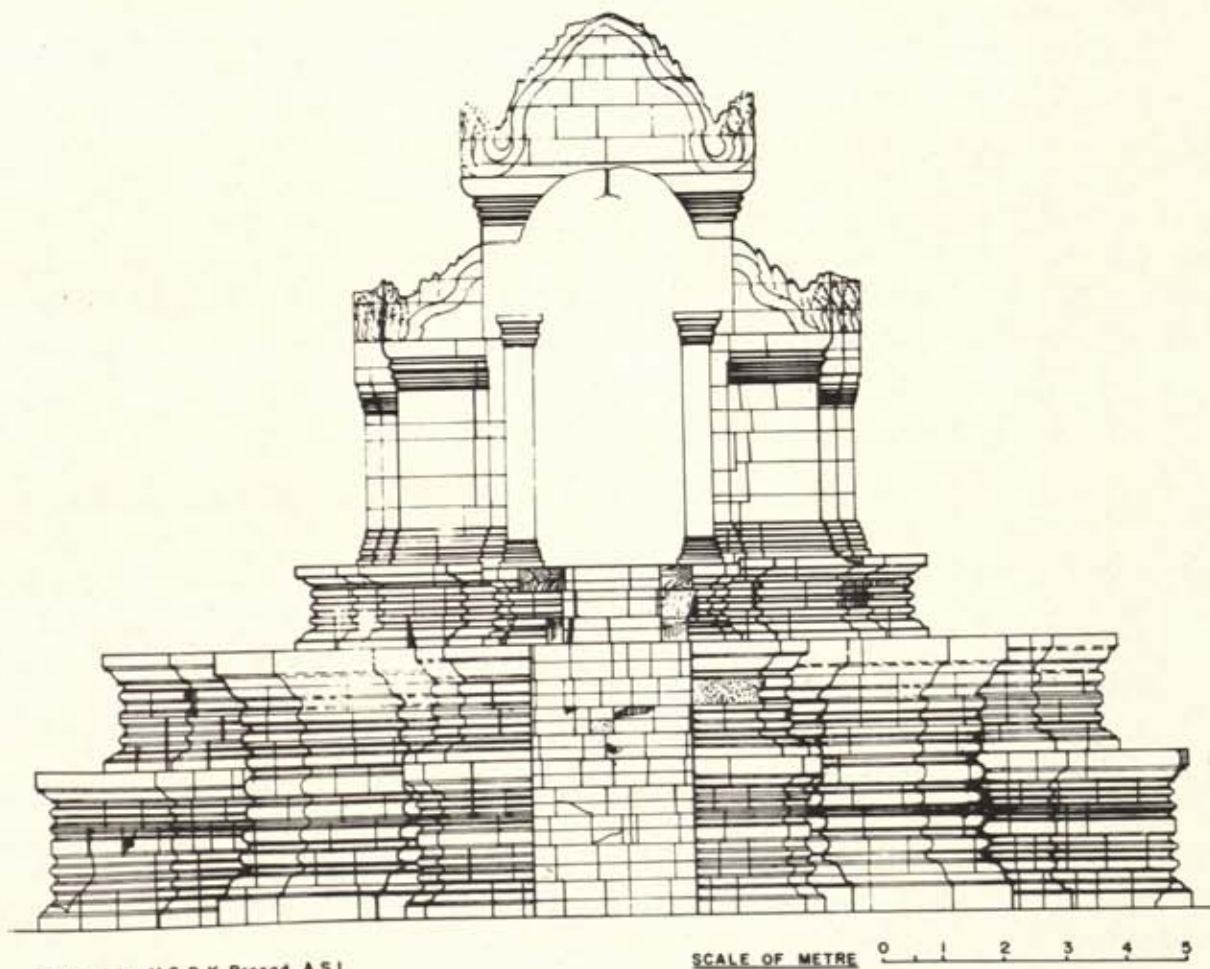
Fig. 11a

EASTERN FAÇADE—The façade (fig. 11) including plinth and stepped entrance flanked by massive balustrades was in dilapidated condition due to horizontal dislodgment of architectural members. The dislodgement of members was so severe in some portions due to heavy growth of vegetation that such portions had to be dismantled and reconstructed as per the original after consolidation of the core which had also suffered damages. In the areas where the dislodgement was not so pronounced, the displaced architectural members were pushed back to their original positions with the help of horizontal jacks and by human efforts (pl. XLIX). While conserving this façade, thirty-six (36) architectural members were dismantled and reset and another nine (9) members were reset without dismantling.

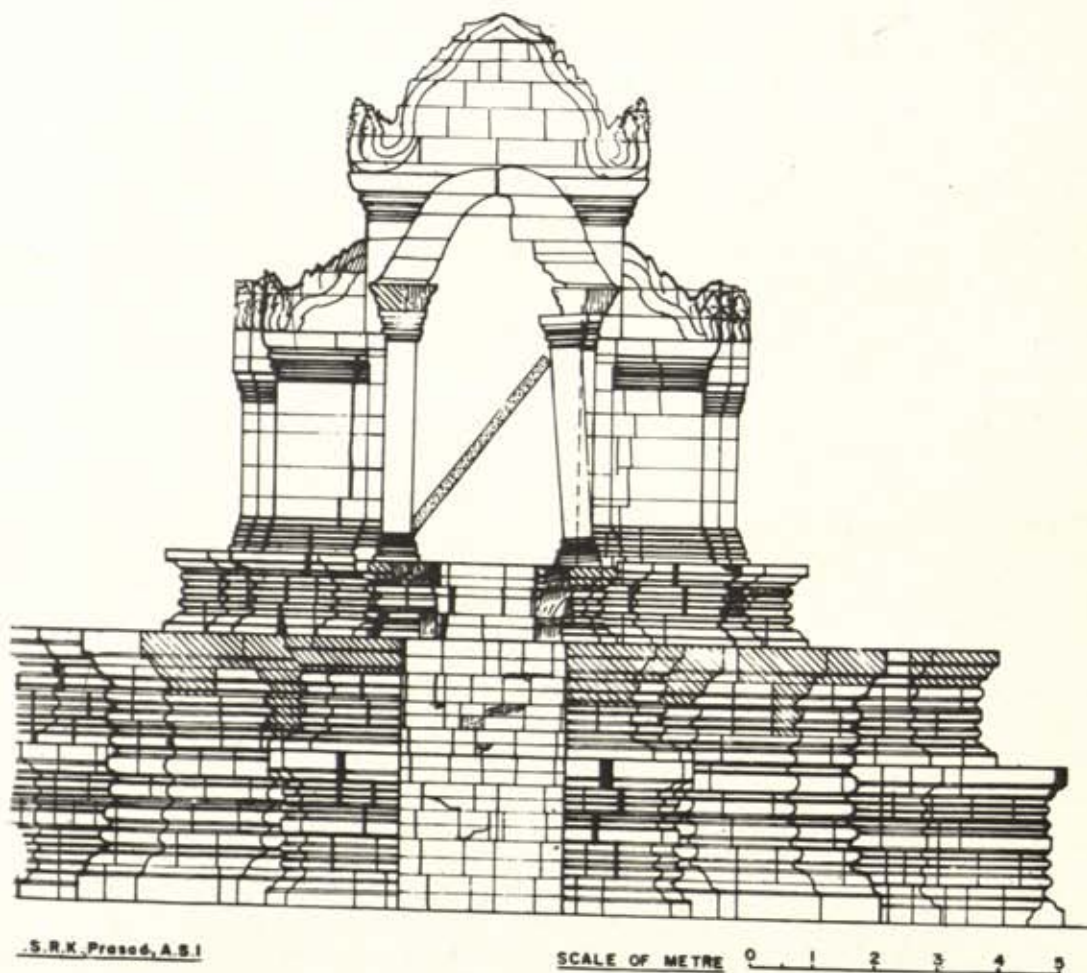
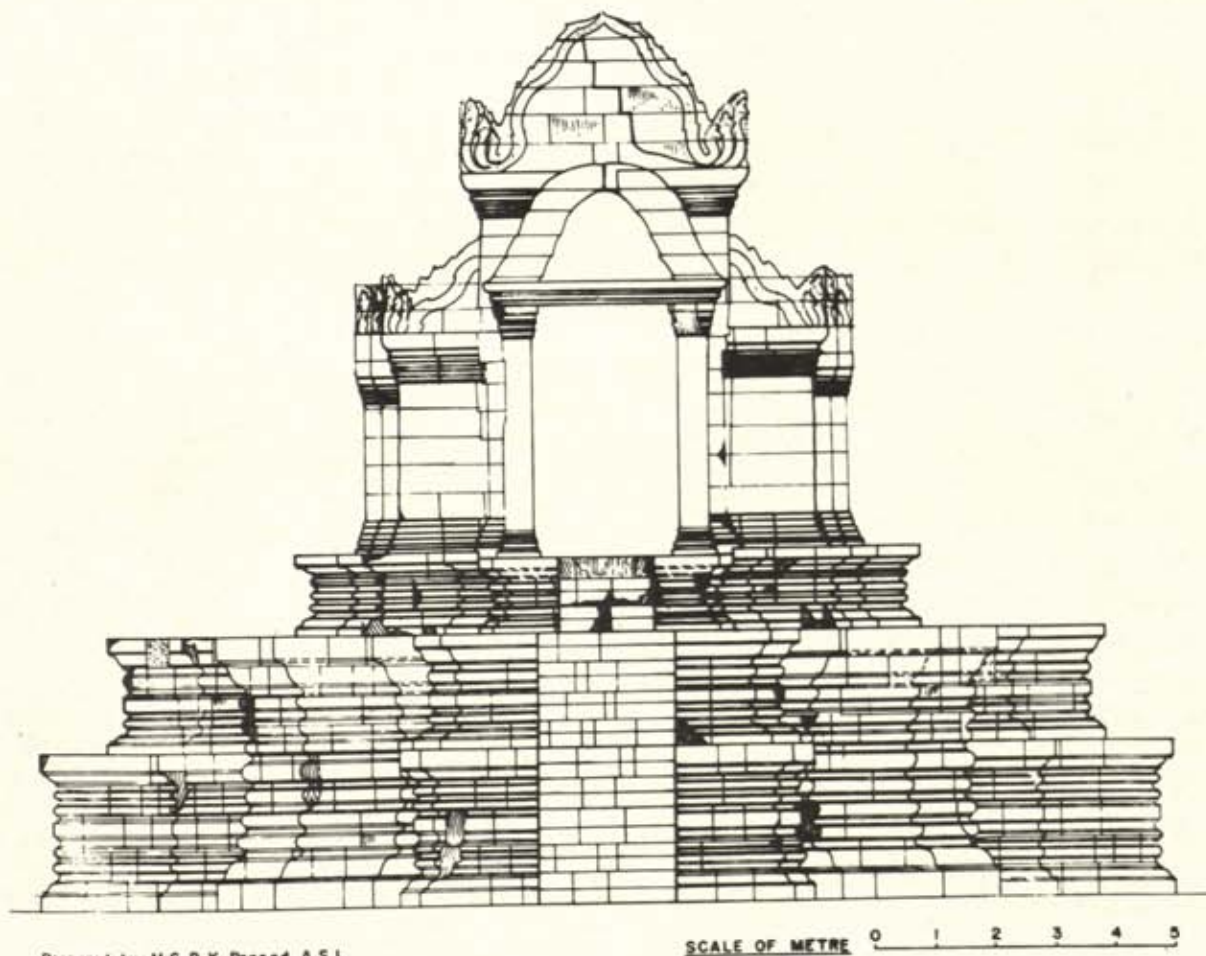
FIG. 12a

WESTERN FAÇADE—The whole of western façade (fig. 12) including massive double plinth stepped entrance flanked by balustrades and landings, entrance porch and topmost *torana* was in dilapidated condition. Therefore, the conservation work had to be carried out with great care on priority basis in a phased manner.

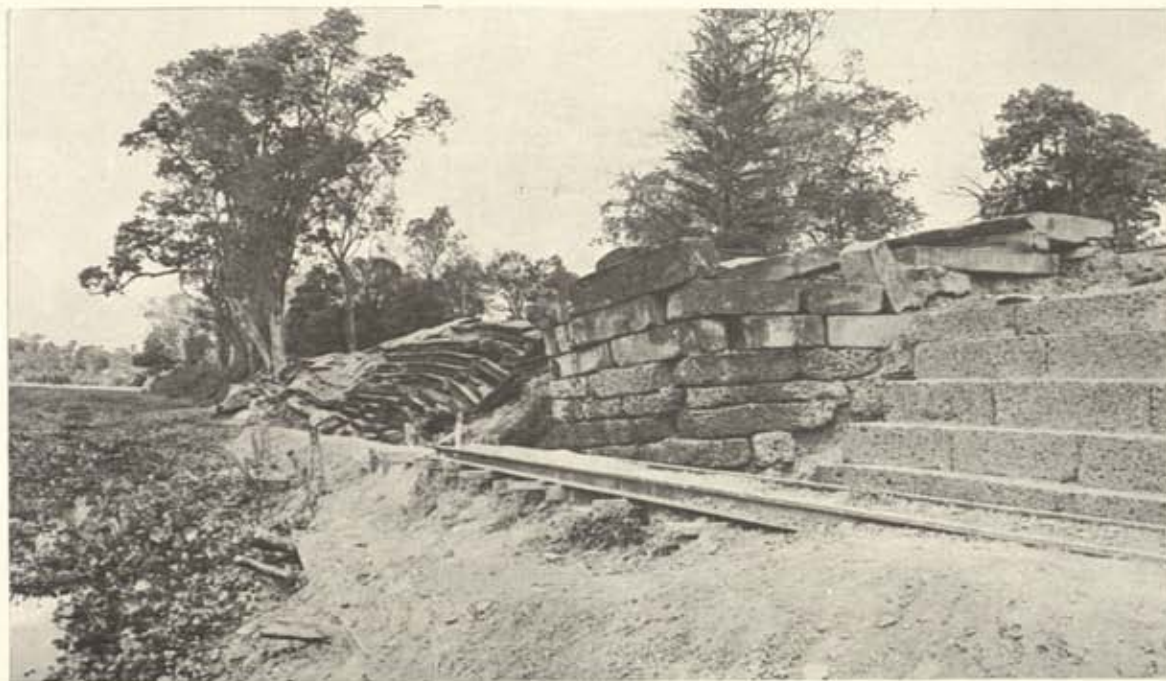
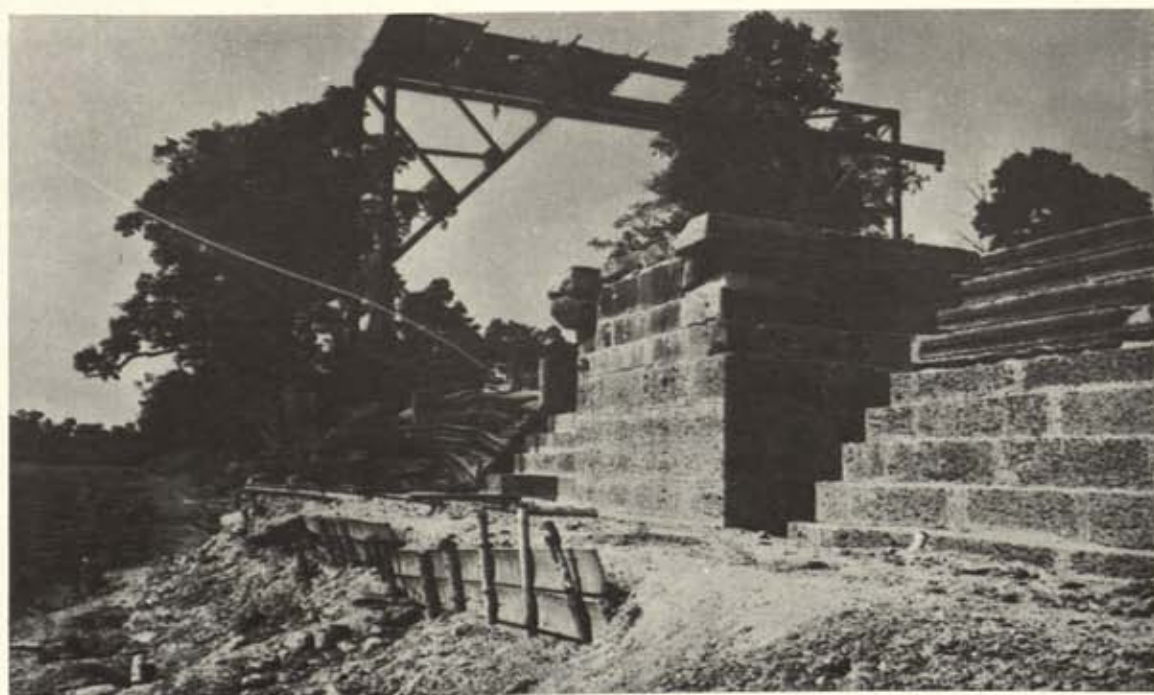
Stepped embankment of moat: A, before and B, after conservation

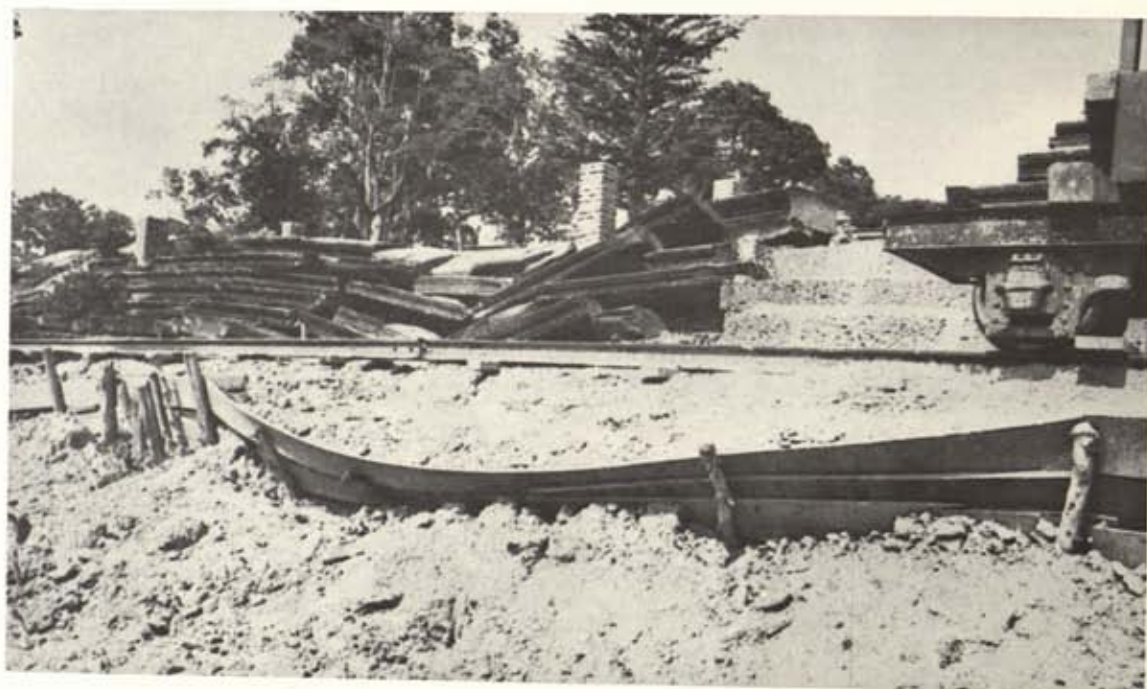
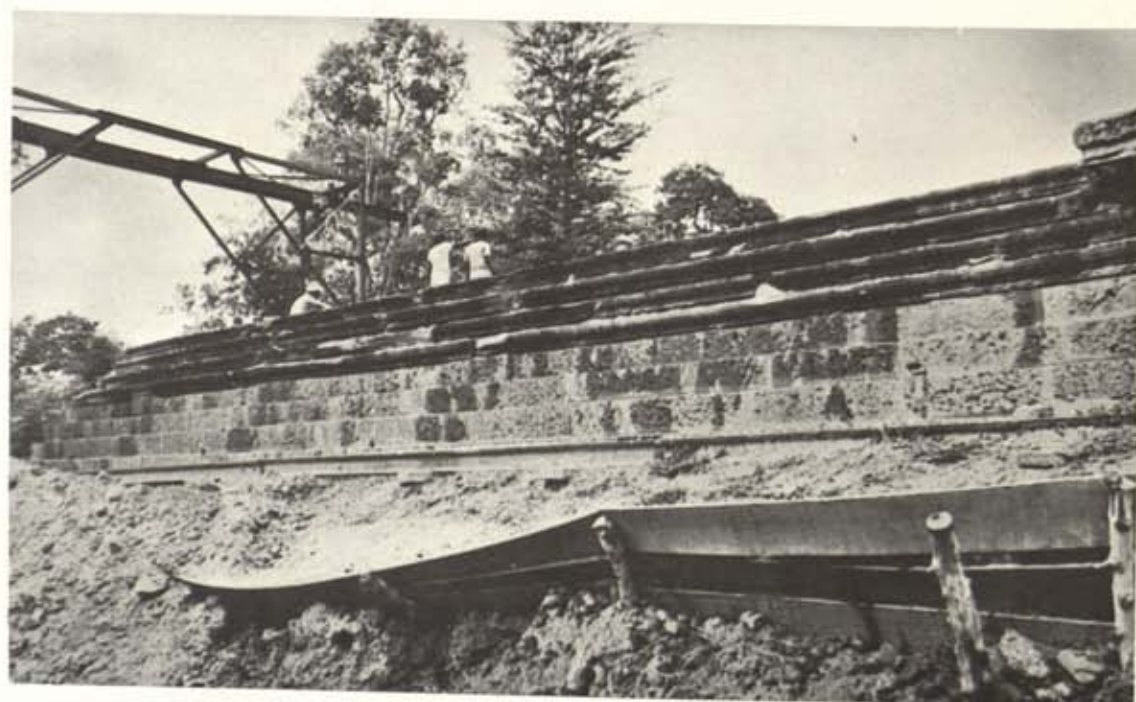
Stepped embankment of moat : A, before and B, after conservation

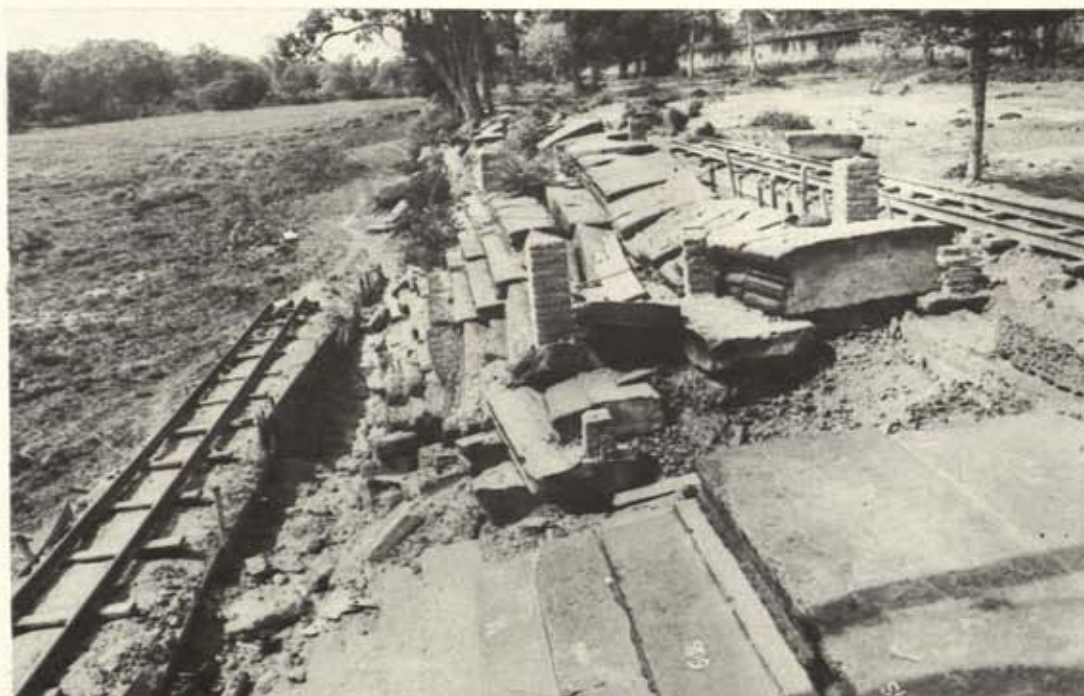
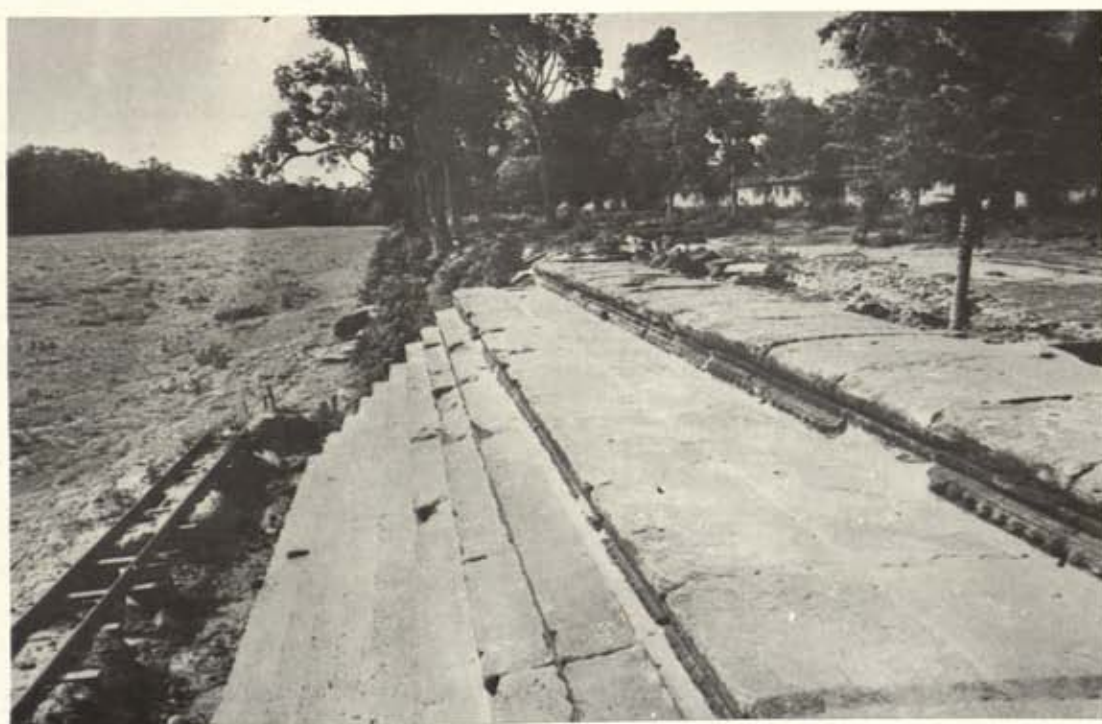
Stepped embankment of moat : A, before and B, after conservation

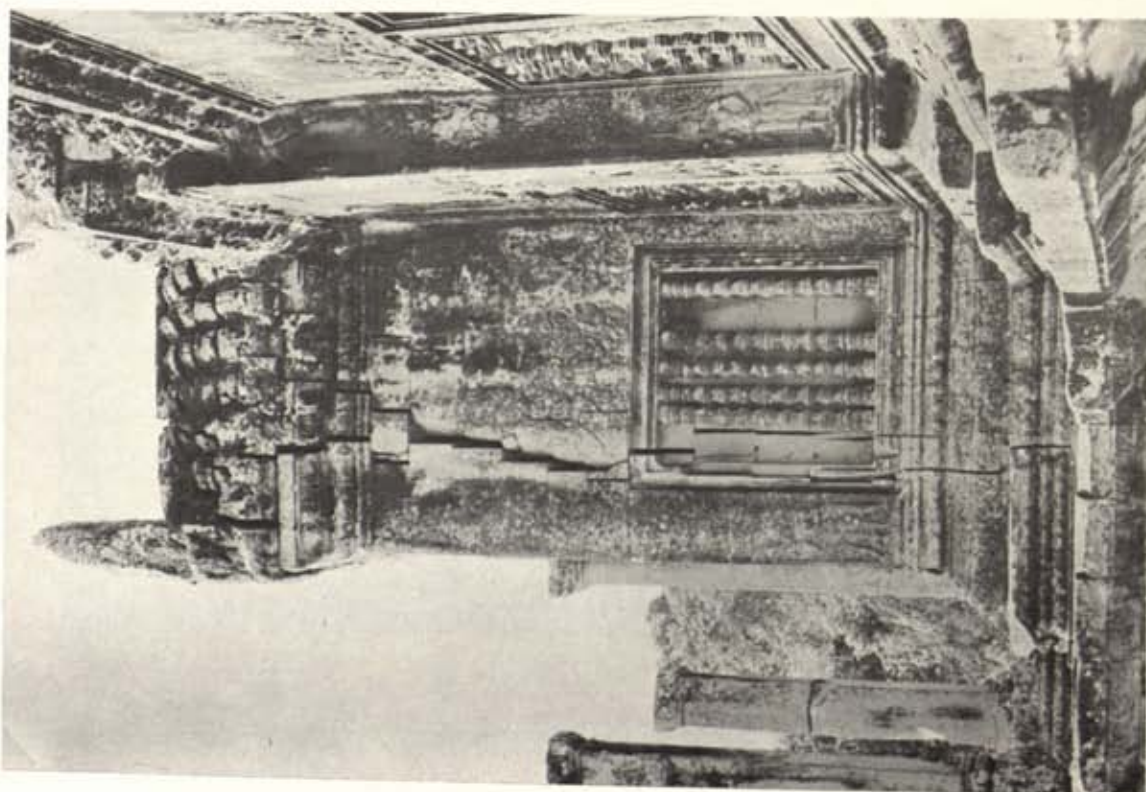
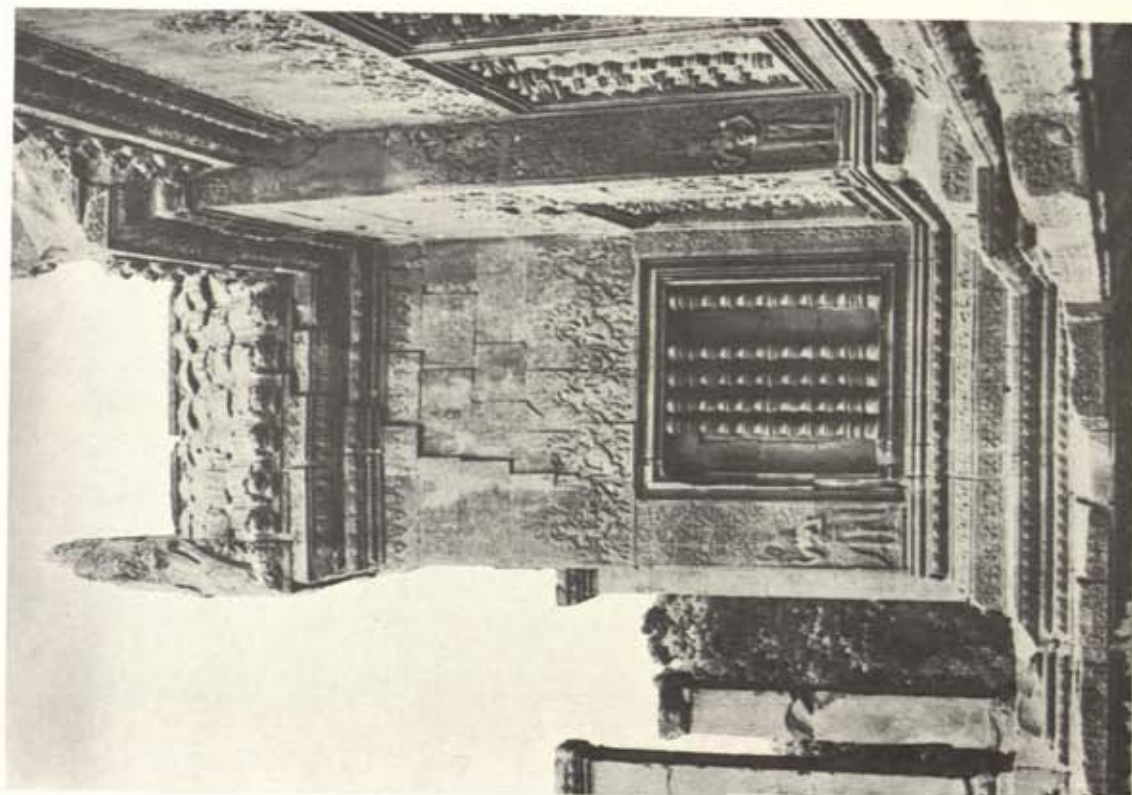
Fourth Enclosure, Western Gateway : torana of an entrance pavilion; A, before and B, after conservation

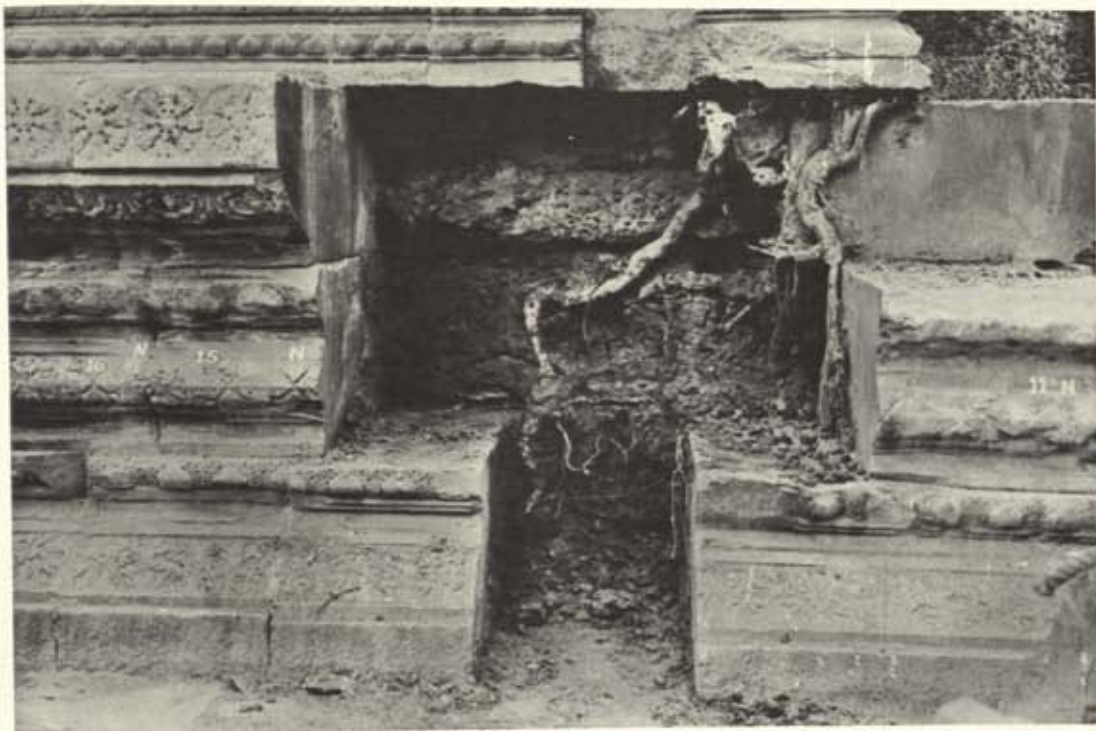
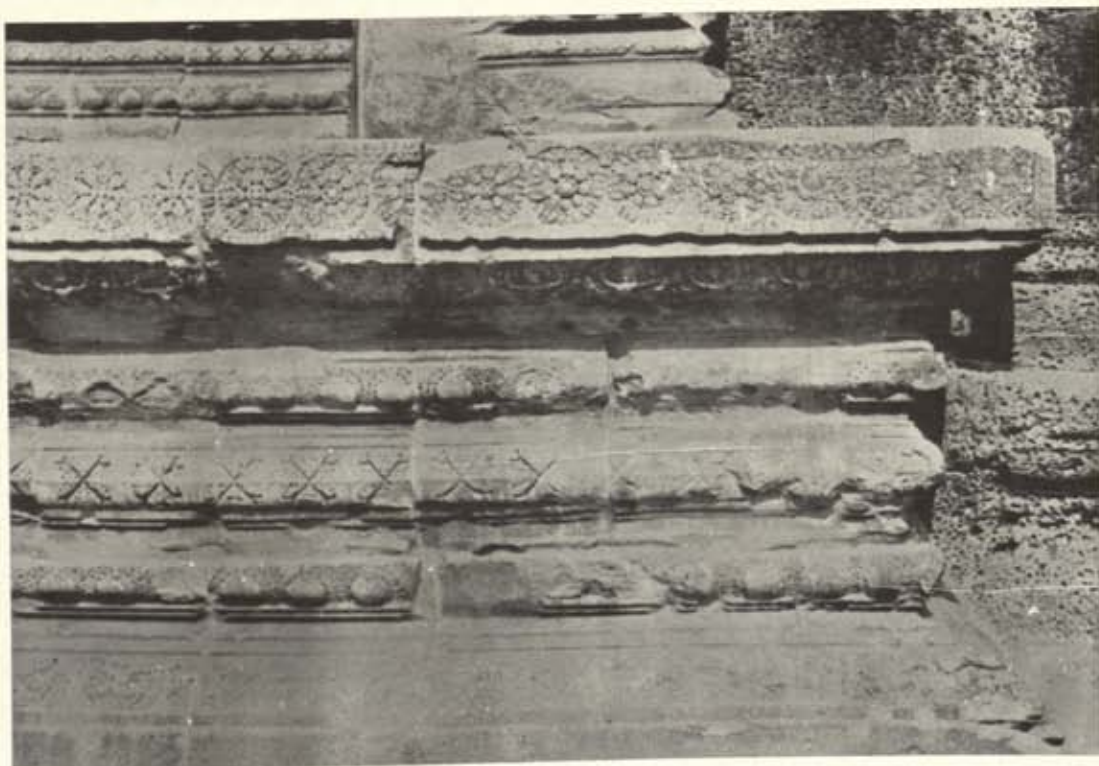
Fourth Enclosure, Western Gateway : plinth of southern elephant gate; A, before and B, after conservation

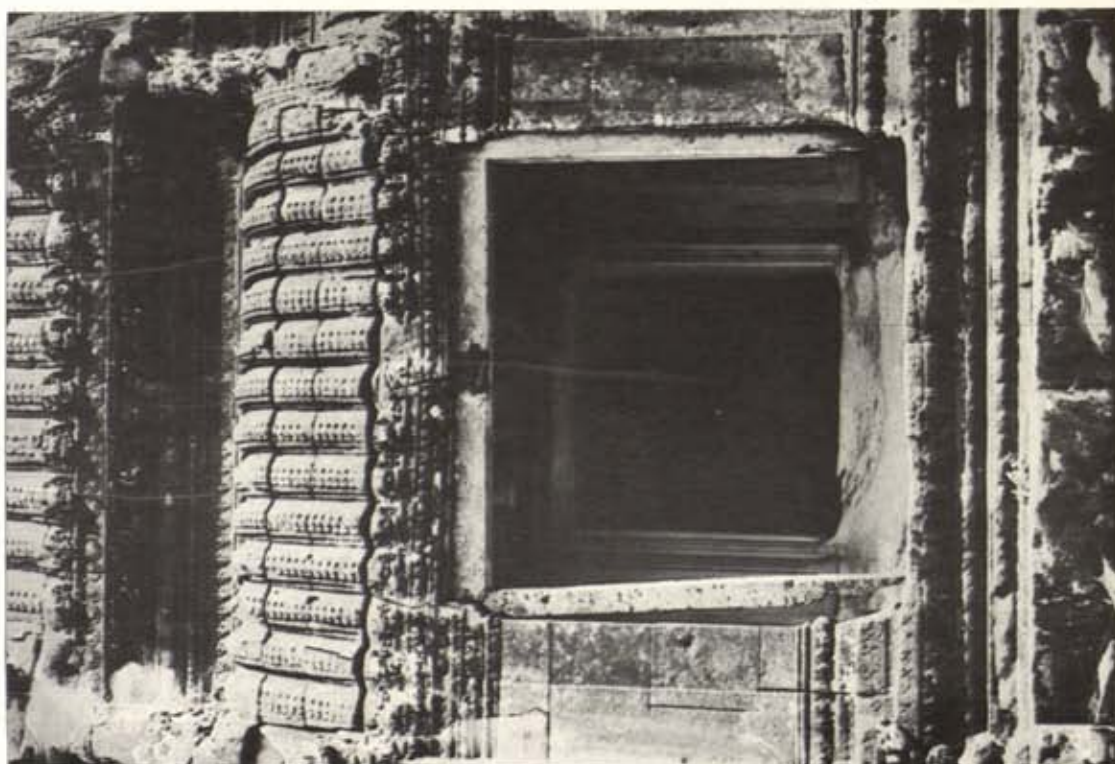
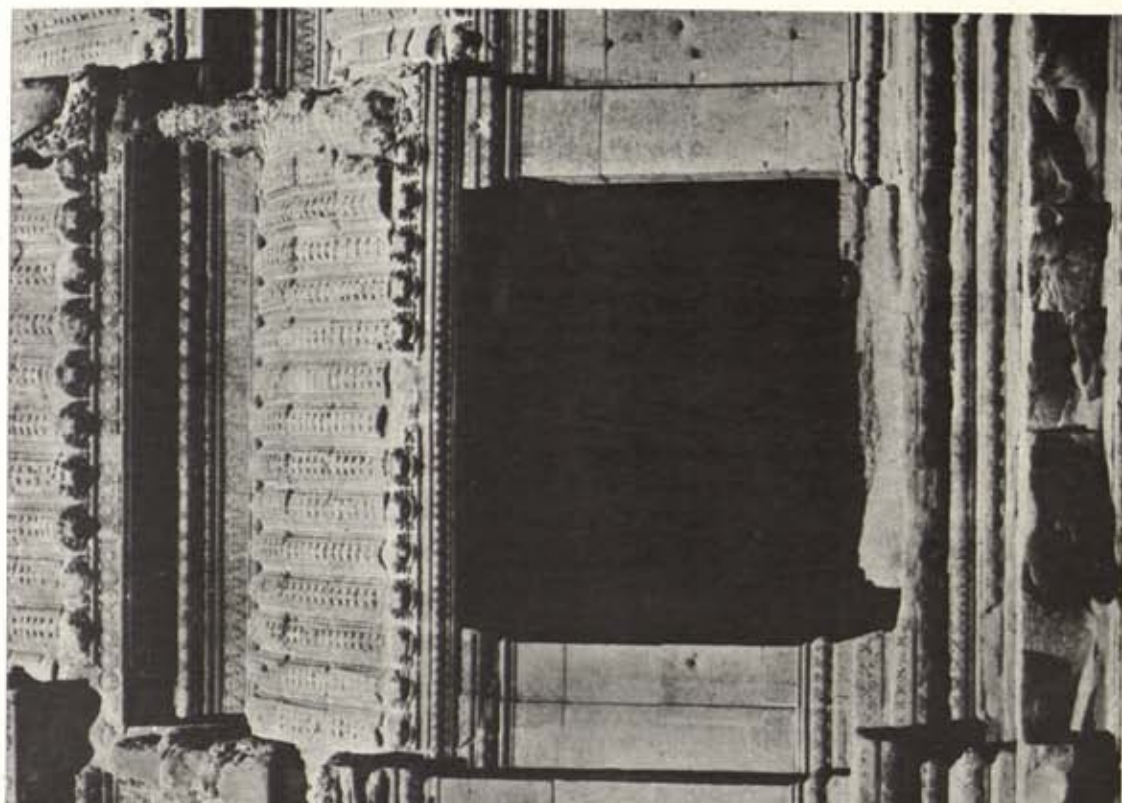
Fourth Enclosure, Western Gateway: beam of semi-vaulted roof, A, before and B, after conservation

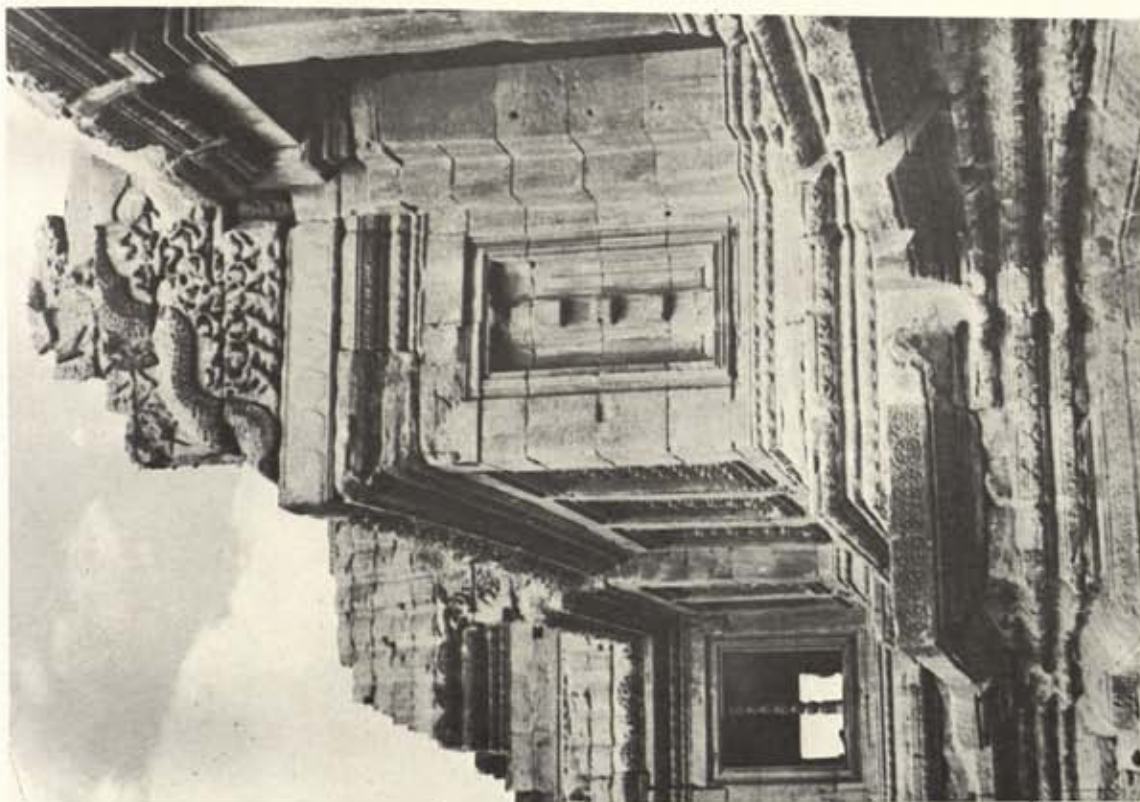
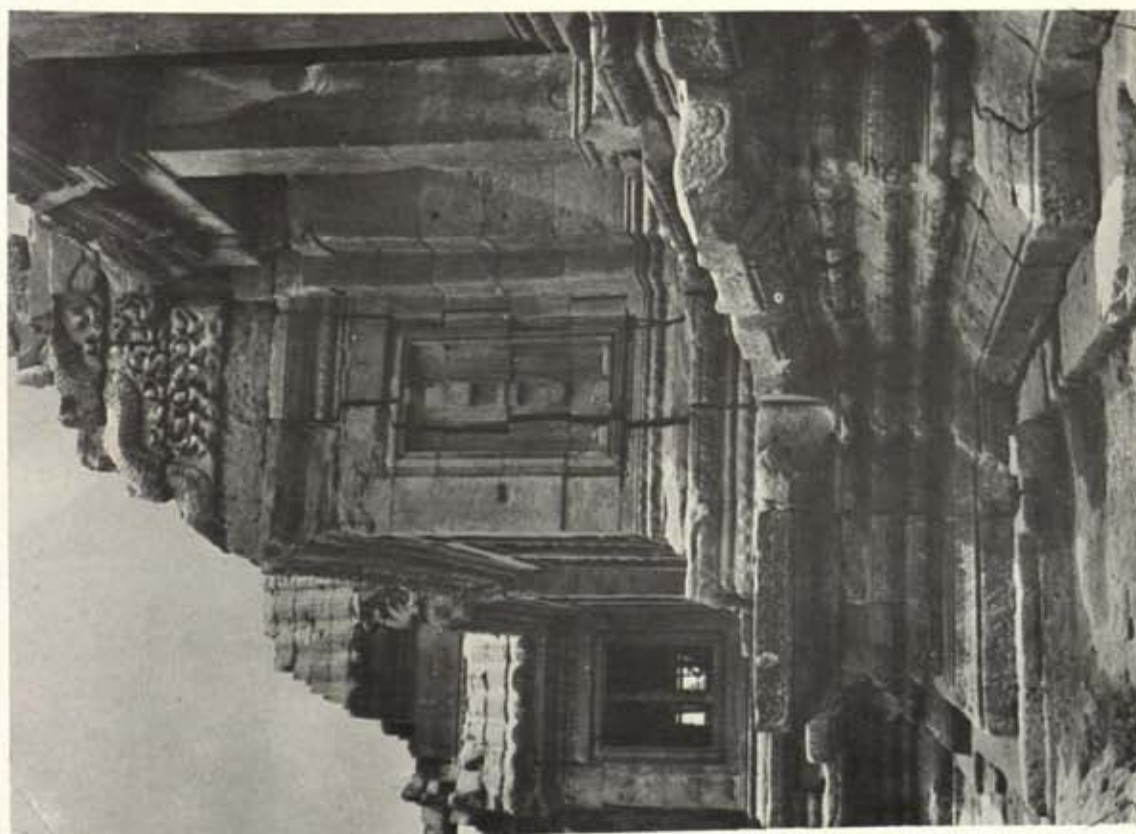
Southern Library between Third and Fourth Enclosures: false window on the western façade, A, before and B, after conservation

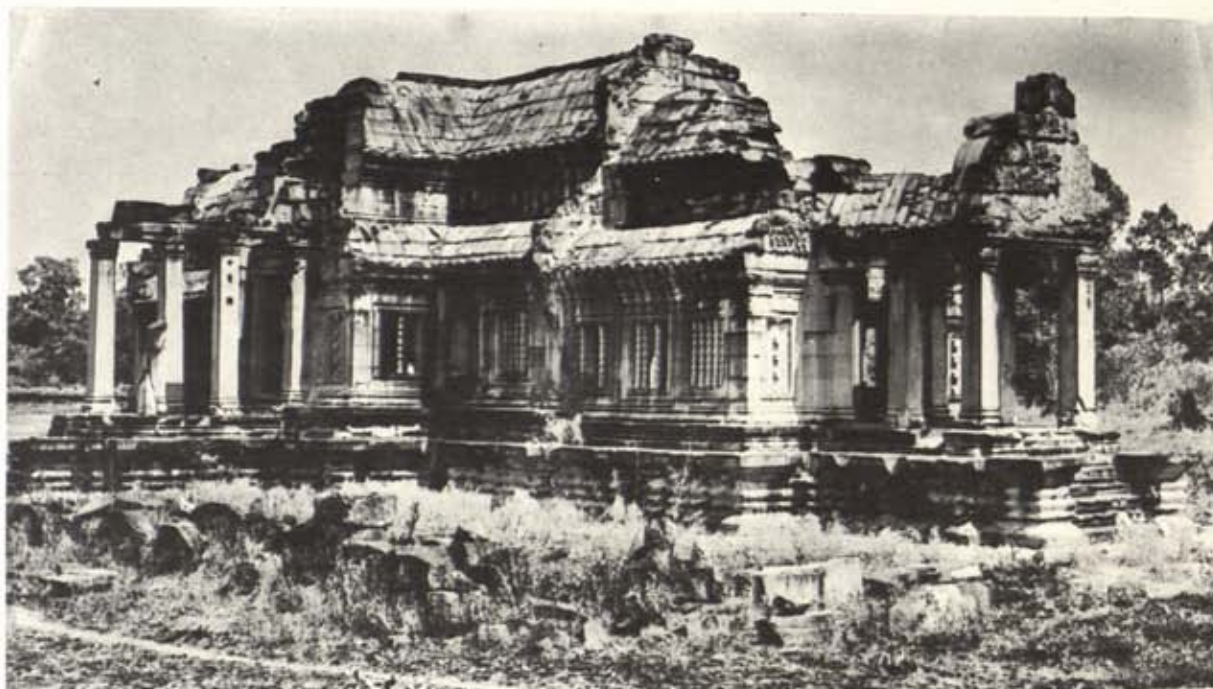
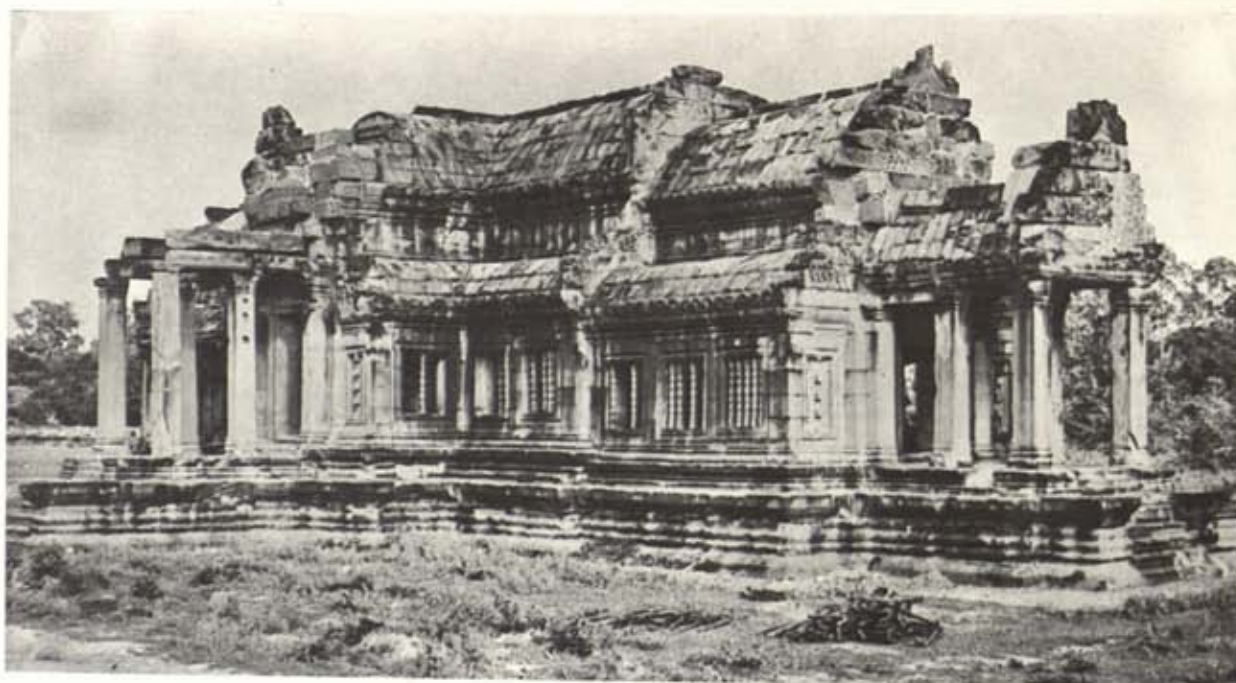
Southern Library between Third and Fourth Enclosures : western mandapa (pavilion), A, before and B, after conservation

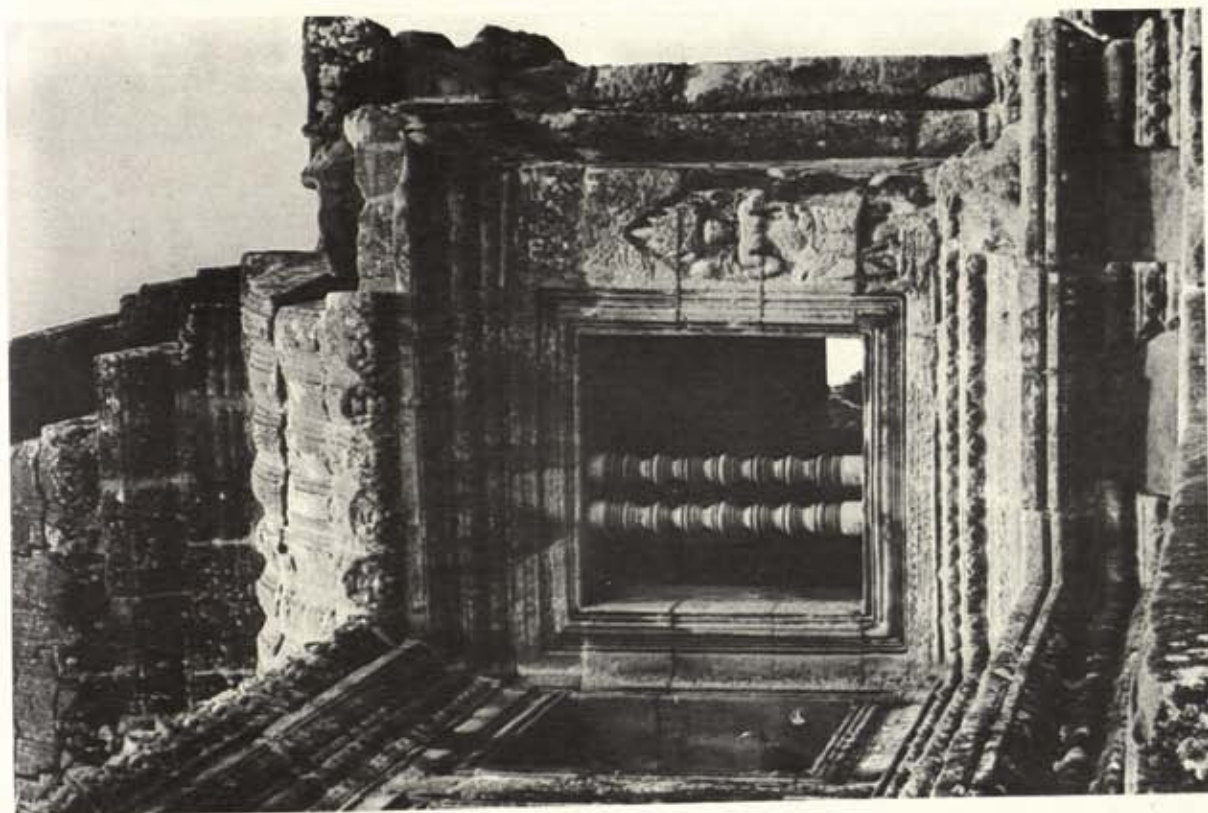
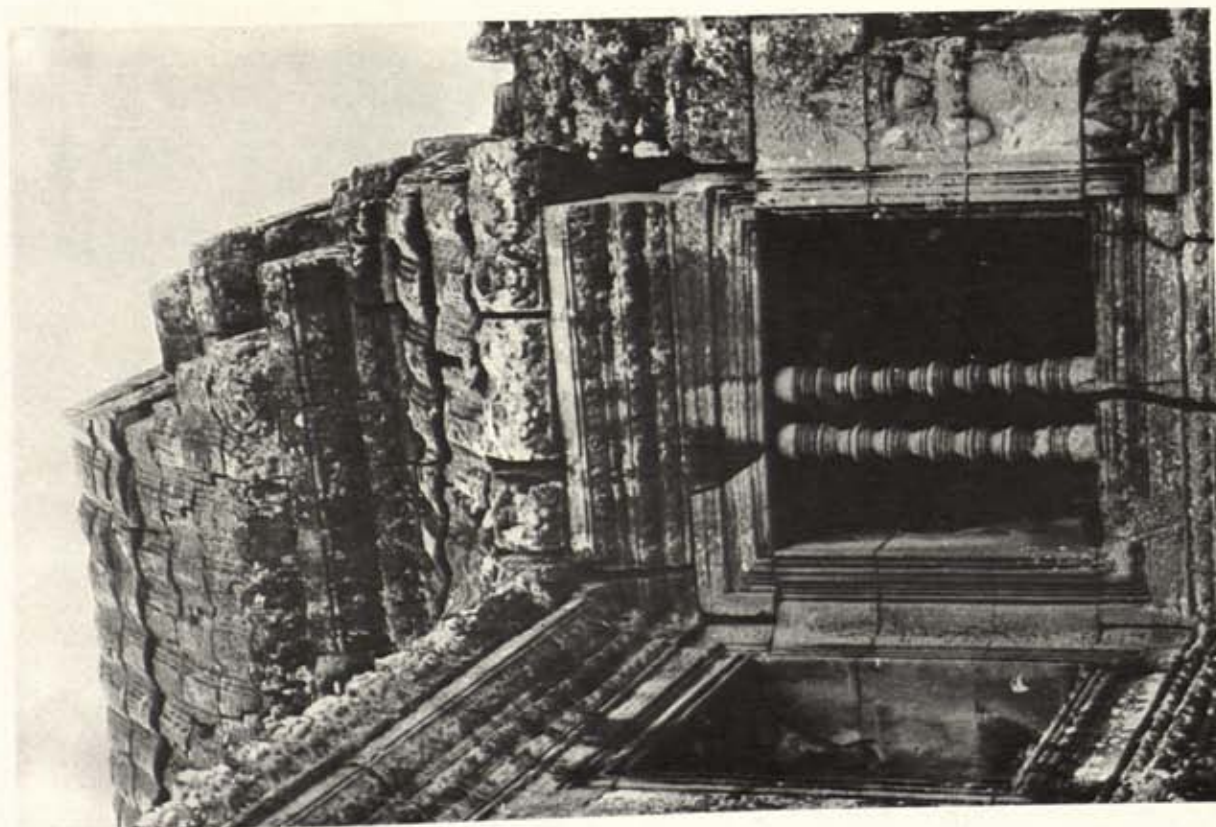
Northern Library between Third and Fourth Enclosures : verandah with semi-vaulted roof at north-eastern corner, A, before and B, after conservation
